Toe support conditions for placed riprap on rockfill dams – A field survey

By Ganesh H R Ravindra, Fjola G Sigtryggsdottir, Malin F Asbølmo og Leif Lia

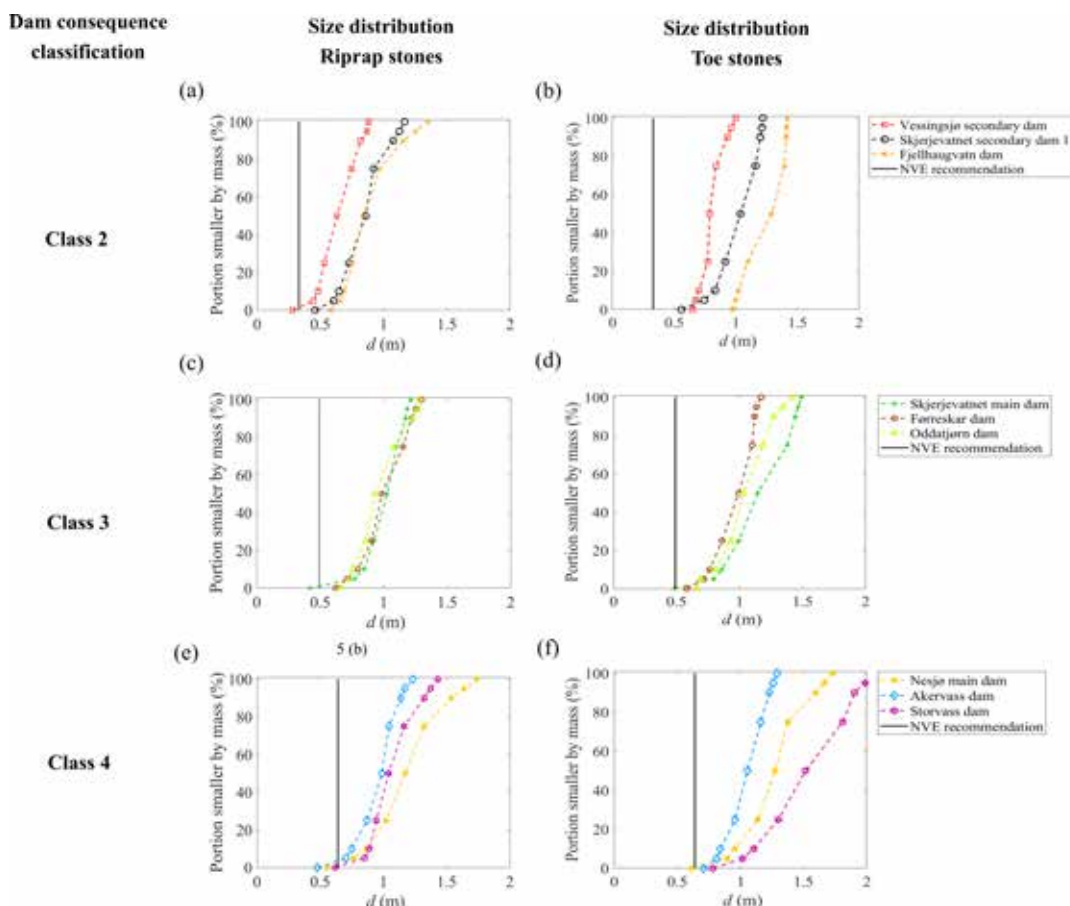
Figures 3a, 3c and 3e depict size distributions for riprap stones from the surveyed placed ripraps constructed on different dams classified within dam safety classes 2, 3 and 4 respectively and Figures 3b, 3d and 3f present size distributions for toe stones from the respective dams. Furthermore, minimum stone sizing recommendations for the respective dam safety classes (equation 3) are presented within the respective plots. It can be observed from the depictions that all dams meet the recommended minimum sizing criteria for all dam safety classes. It should also be noted that the sizing of the riprap stones was in general closely resembling the sizing of the toe stones with $d_{50,T} / d_{50,RR}$ ranging from 1 to

1.25 with $d_{50,T} / d_{50,RR}$ representing the ratio of median toe stone size to that of the riprap stones. However, for Fjellhaugvatn dam (Figures 3a and 3b) and for Storvass dam (Figures 3e and 3f), the toe stones were found to be of comparatively larger sizing than the riprap stones with $d_{50,T} / d_{50,RR}$ of 1.53 and 1.45 respectively.

Figure 3. Panels a, c and e present size distributions for riprap stones from dams classified within consequence classes 2, 3 and 4 respectively. Panels b, d and f present size distribution for toe stones from dams classified within consequence classes 2, 3 and 4 respectively.

The size distributions for the riprap and the toe stones presented as Figure 3 demonstrate that the stones employed for construction are of larger sizing in comparison with NVE recommendations. Further, Figure 4 depicting the ratio of the maximum to the minimum stone dimensions show that sizing of riprap and the toe stones were non-uniform in nature ($d_{max} / d_{min} > 1.7$) as opposed to the NVE recommended $d_{max} / d_{min} < 1.7$. Furthermore, majority of

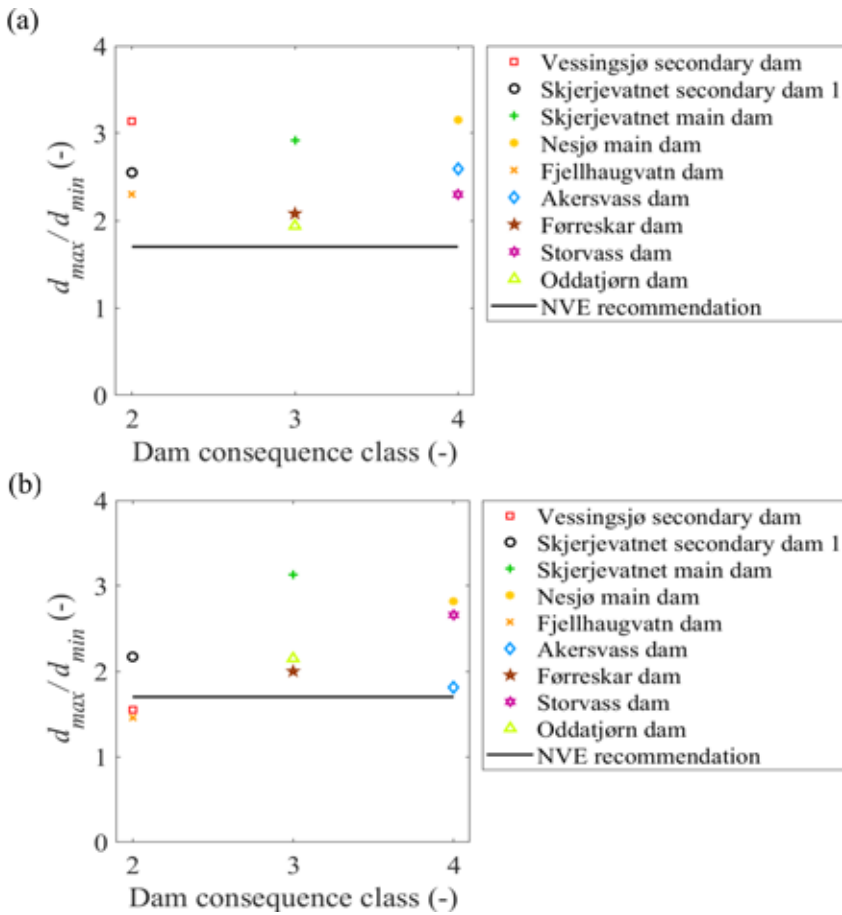
Further, the NVE guidelines for design and construction of placed ripraps also recommend that the ripraps should be comprised of uniform sized stones conforming to the criteria $d_{max} / d_{min} < 1.7$ (NVE, 2012). Figures 4a and 4b portray the ratio of the maximum to the minimum stone diameters for the riprap and the toe stones respectively from all the surveyed dams. The NVE guideline in this regard has also been overlaid

within these plots. The depictions demonstrate that none of the dams meet the criteria considering size distribution of the riprap stones (Figure 4a). Two of the dams, Vessingsjø secondary dam and Fjellhaugvatn dam met the recommendation with regards to size distribution of the toe stones (Figure 4b).

Figure 4. Panel a present plots depicting the ratio of the maximum to minimum stone diameters for the riprap stones for all the surveyed dams. Panel b presents the ratio of the maximum to minimum stone diameter for the toe stones for all the surveyed dams.

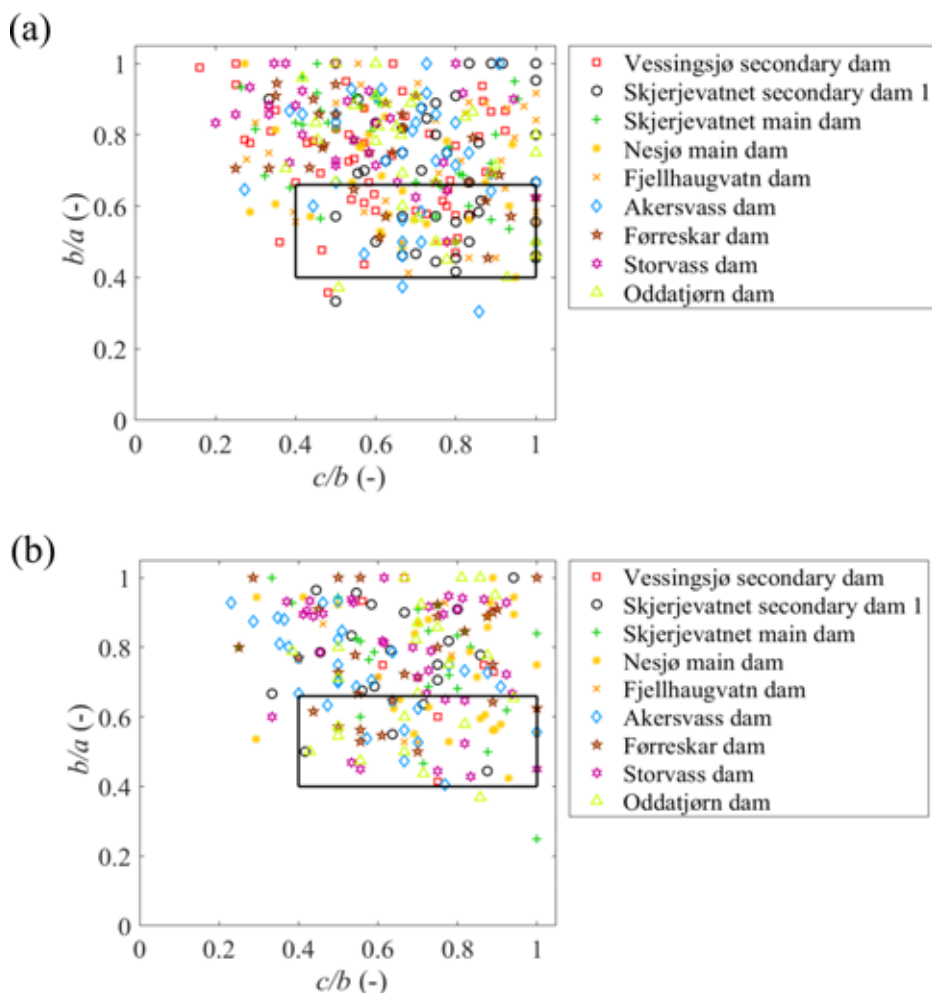
Figures 5a and 5b portray Zingg diagrams for all the measured riprap and toe stones respectively from the surveyed dams. Majority of the measured riprap stones (67 %) lie outside of the NVE specified region within the Zingg diagram with dense clusters formed at the disc to the spheroidal regions (Figure 5a). This was a trend observed also for the toe stones with 69% of the measured toe stones lying outside of the NVE recommended region with cluster formation

closely resembling that of the riprap stones (Figure 5b).

Figure 5. Panel a presents a Zingg diagram for all the measured riprap stones, and panel b presents a Zingg diagram for all the measured toe stones.

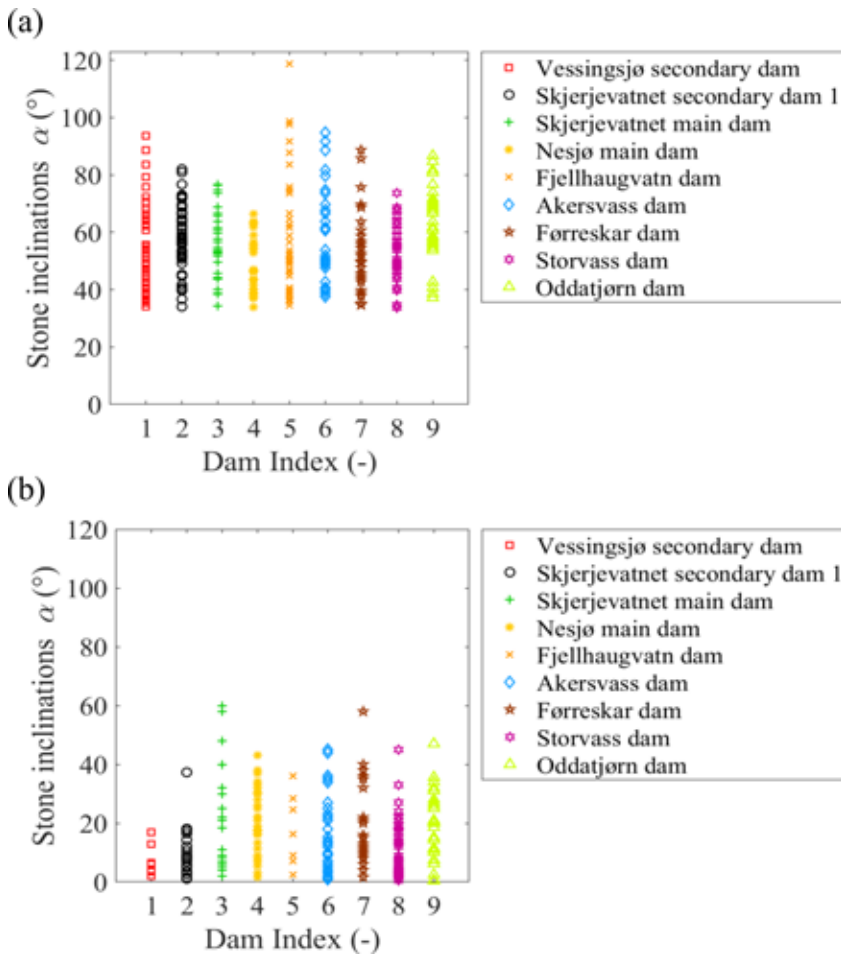
Figures 6a and 6b present the computed inclinations (α) for the riprap and the toe stones respectively for all the surveyed dams. The dam index in the respective plots represent the designations assigned for the individual dams as shown in Table 1. As can be inferred, the computed α

angles varied over broad ranges of 30° to 120° for the riprap stones and from 0° to 60° for the toe stones. The average placement inclinations for the riprap and the toe stones from all the surveyed dams were found to be $\alpha_{RR} = 56^\circ$ and $\alpha_T = 16^\circ$ with α_{RR} and α_T representing mean inclination for the riprap and the toe stones for all the surveyed dams respectively.

Figure 6. Panel a presents computed inclinations (α) for the riprap stones from all the surveyed dams. Panel b presents computed inclinations (α) for the toe stones from all the surveyed dams.

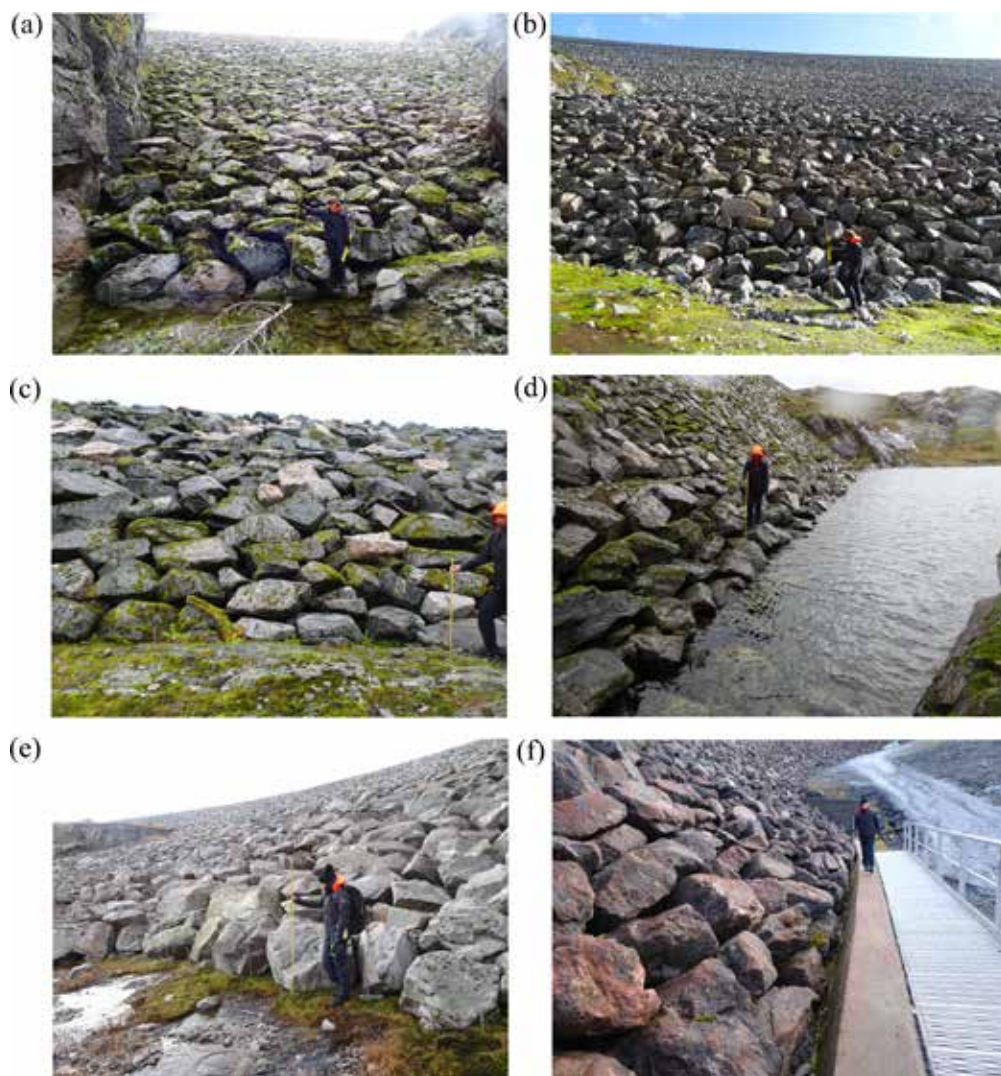
of soil cover. Illustrations of these toe support conditions are presented for dams Fjellhaugvatn, Oddatjørn and Skjerjevatnet main dam in Figure 7a, 7b and 7c respectively. Toe stones at Fjellhaugvatn dam and Skerjavatnet main dam were found to be resting on rock surfaces whereas toe stones at Oddatjørn dam were buried under moderate soil cover.

The second category of observed riprap toe conditions at the surveyed dams consists of submerged riprap toe sections. This was the case at certain reaches of riprap toe sections of Skjerjevatnet main dam and Skerjevatnet secondary dam 1. An illustration of the scenario at Skjerjevatnet main dam is depicted in Figure 7d.

Figure 7. Depiction of existing conditions of placed riprap toe sections. Category 1 at dams (a) Fjellhaugvatn dam (b) Oddatjørn dam and (c) Skjerjevatnet main dam. Category 2 at (d) Skjerjevatnet main dam. Category 4 at (e) Storvass dam. Category 5 at (f) Akersvass dam.

The fourth category of riprap toe construction observed was the use of steel bars for stabilization of the toe stones. A small section of the riprap toe at Storvass dam was observed to be supported employing reinforcing steel bars (Figure 7e) measuring 25 mm in diameter with average out-crop length of 0.3 m. Although majority of the riprap toe sections of Storvass dam were observed to be unsupported, the reinforcing bars were used to stabilize toe sections of the riprap close to the right abutment where the foundation was observed to be at a steep inclination.

At Akersvass dam, a small stretch of the riprap toe section was seen to be supported with a concrete wall (Figure 7f) and this is classified as the fifth riprap toe state observed as part of this field study. The concrete wall was constructed in tandem with a leakage measuring station and hence, it was evident that riprap toe stabilization was not the primary intention of constructing the structure but rather to facilitate leakage measurements from the dam.

Observations made with regards to toe support conditions for placed ripraps on the surveyed dams suggest that none of the ripraps are currently equipped with well-defined toe support structures. Since the current understanding of failure mechanisms of placed ripraps stems from experimental investigations conducted on model ripraps with fixed toe supports, it seems necessary to investigate the importance of toe support in discerning the failure mechanism and in turn, overall stability of placed ripraps. To address this concern, experimental overtopping tests on model placed ripraps with unconstrained toe sections have been recently conducted at the hydraulic laboratory of NTNU, Trondheim. Investigation outcomes suggest sliding as the failure mechanism in placed ripraps without a fixed toe support in contrast with the buckling failure mechanism described by Ravindra et al. (2019) for the same placed riprap model coupled with a fixed toe support structure. Further, the average ratio of failure discharges for placed ripraps with and without

These observations suggest that toe support conditions can have significant impact on overall stability of placed ripraps. Since existing placed ripraps on Norwegian rockfill dams are constructed without any form of toe support, it is essential to stabilize toe sections of these structures to enhance overall stability. Further experimental investigations in this regard to arrive at ideal methods for providing toe support for existing placed ripraps is recommended.
