Designing a fishway for sea trout (*Salmo trutta*) in a small river in South-Eastern Norway using an adaptive strategy approach

Rike Maria Varelmann

Masterstudent, Ecology and Environmental Management, USN

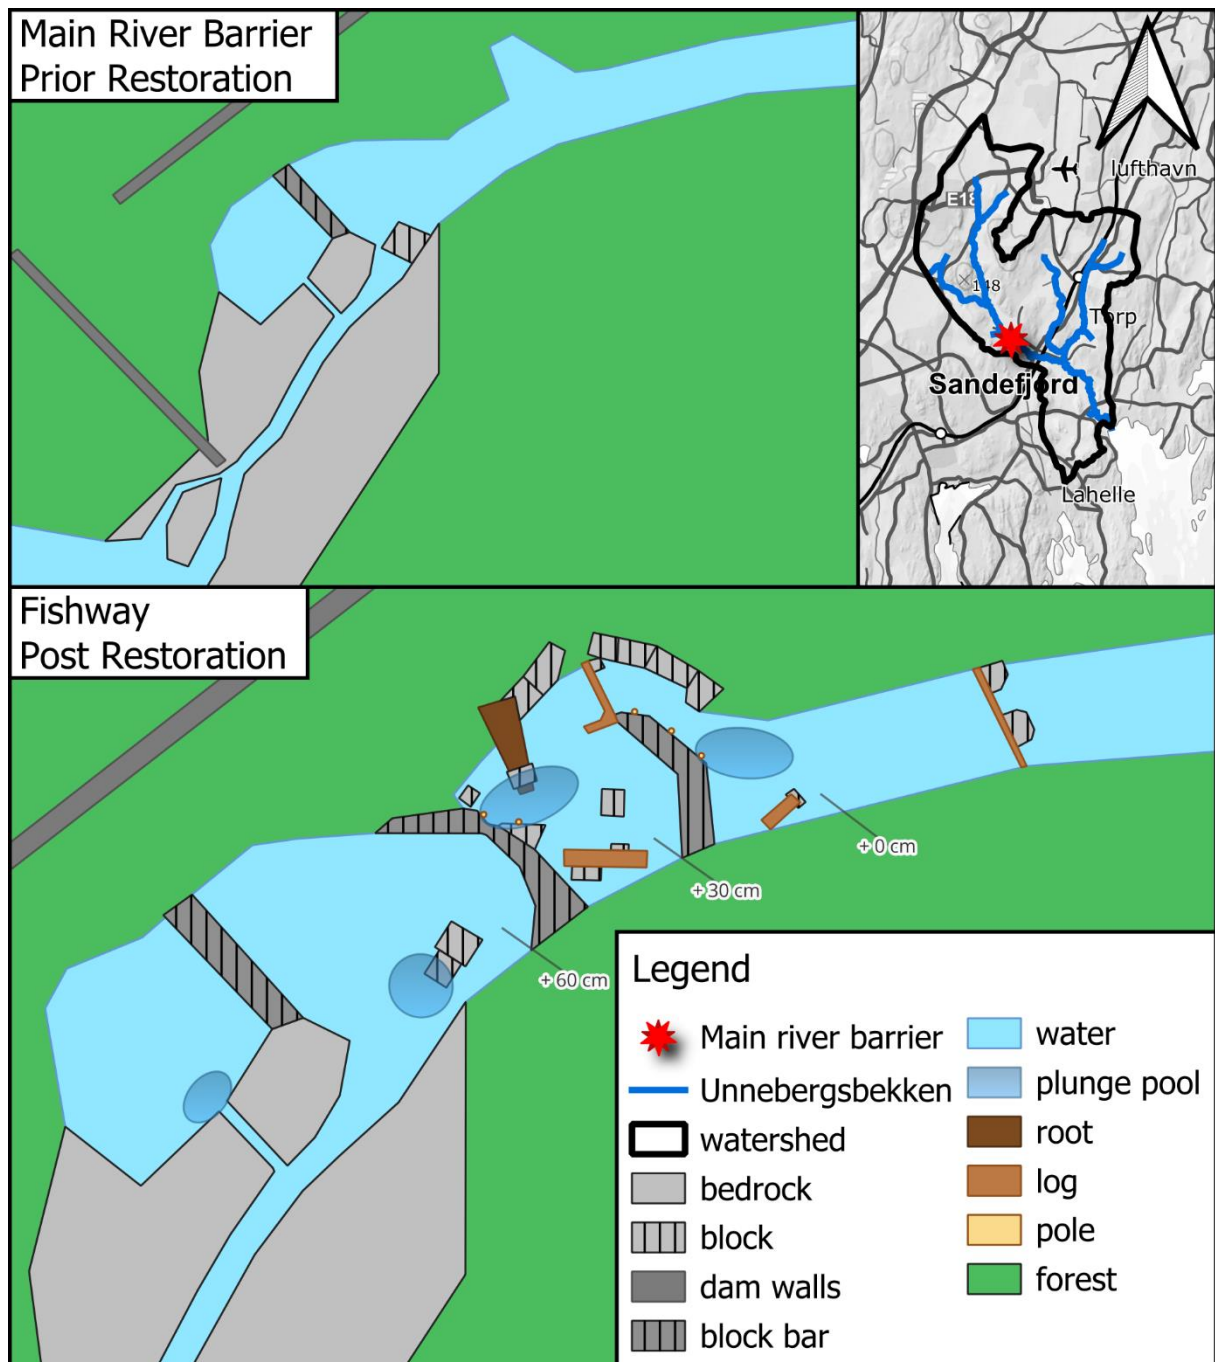
Figure 1 The main river barrier and the step-pool fishway. Map: Topografisk Norgeskart gråtone © Kartverket.

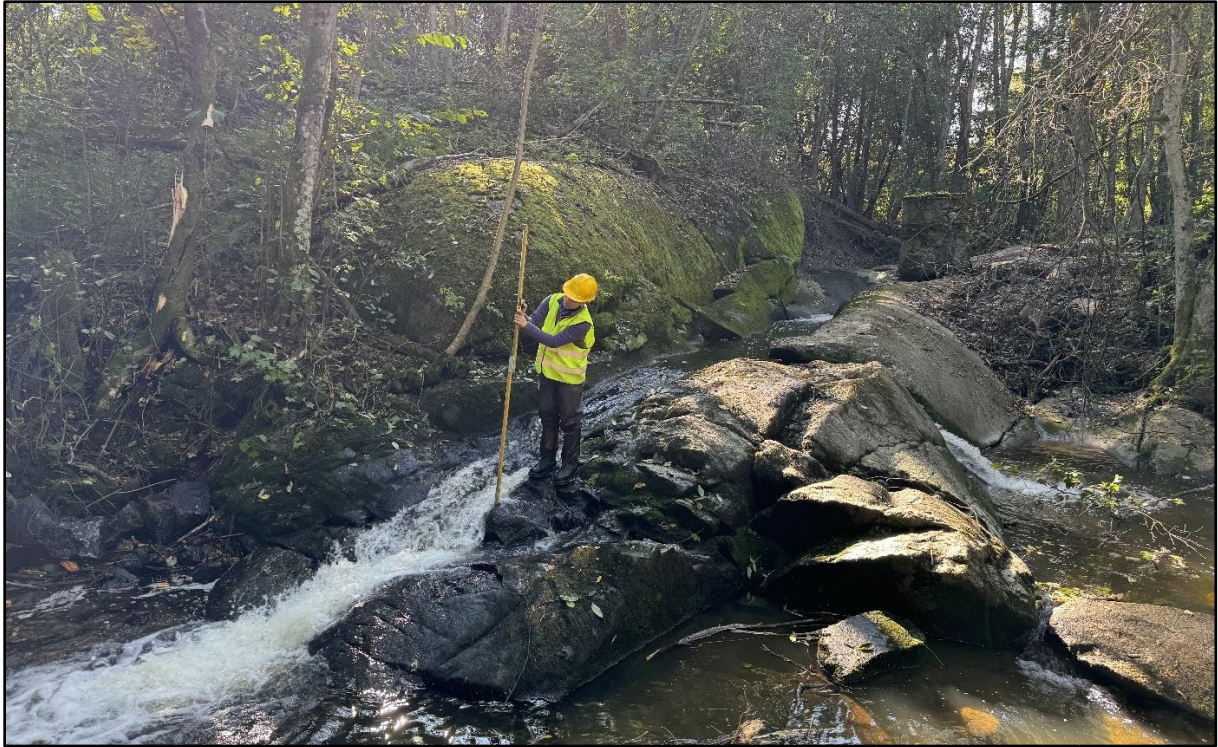
Figure 2 Measuring the main river barrier.

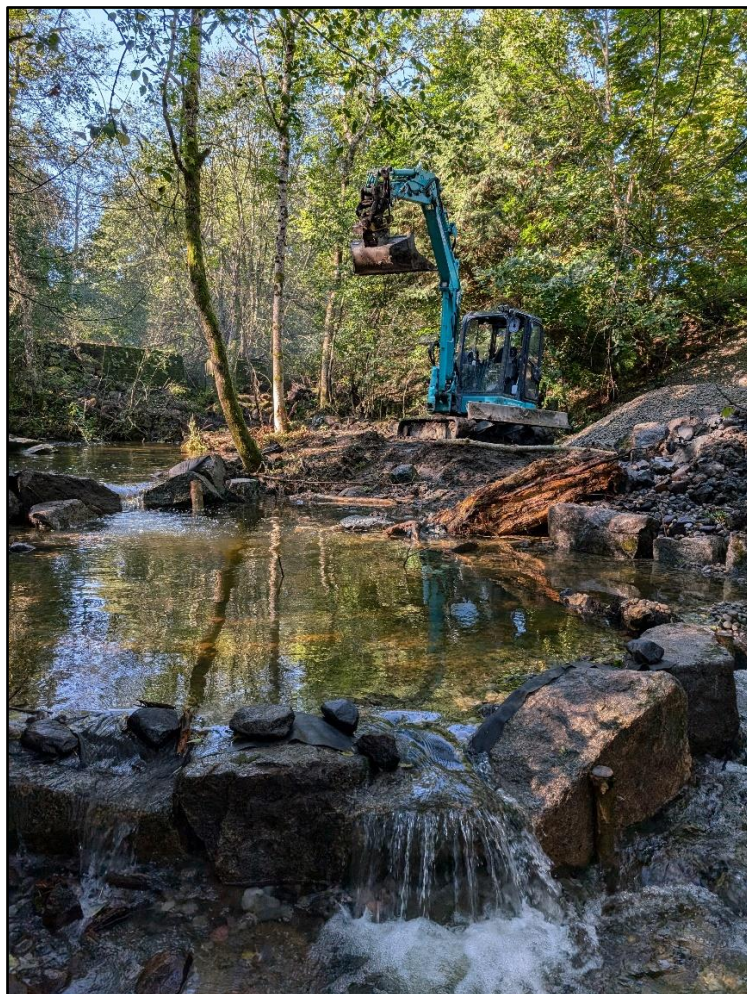
Figure 3 The fishway under construction.

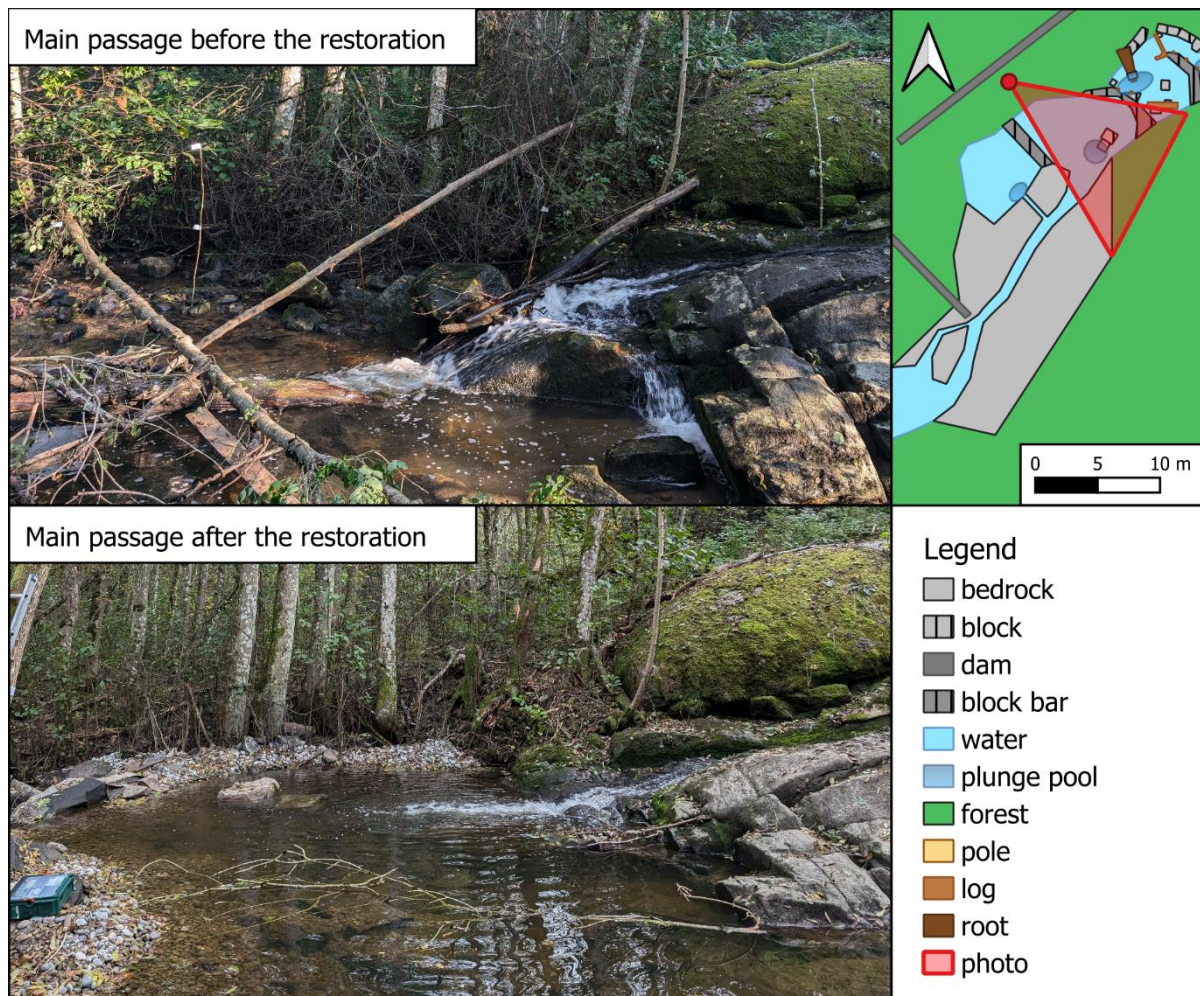
Figure 4 Photos of the water level below the main river barrier before and after the restoration.
