- Gudenåen 4 projects
- Elleskov Water Mill and sucessful stakeholder engagement

CASE STUDIES – Restoration of Danish Rivers

Environmental Protection Agency
The Danish Take on the WFD in rivers
Page 7

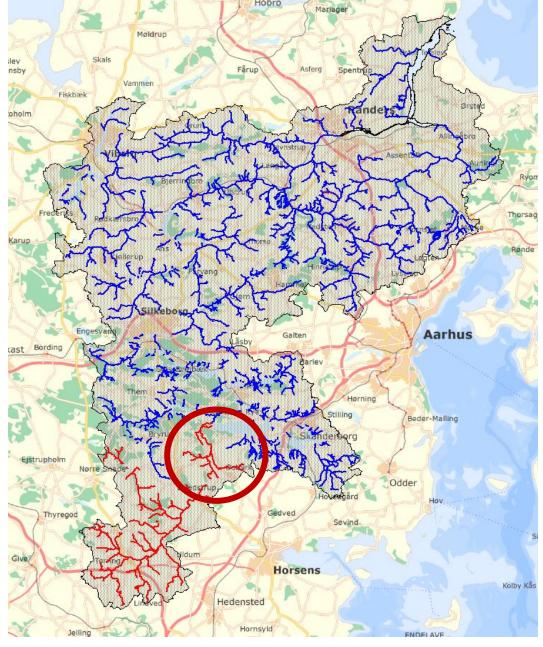
- Randers Fjord catchment is a 1,870km river system
- 225km upstream Klostermølle water mill at Mossø (in red)
- 4 projects to establish river continuity (circled in dark red) in Gudenåen

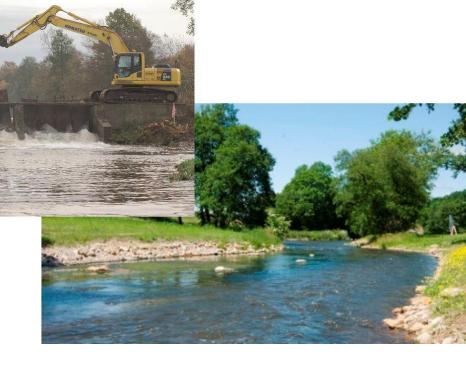
- Vilholt MillWeir and mill pond removed in 2008
- New riffle stretch with stone and gravel substrate

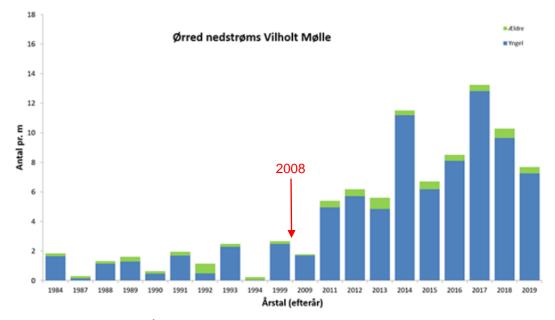
Figur 1: Tætheden af ørred på en 600 meter lang strækning ved Vilholt opdelt i yngel og ældre. Den gennemsnitlige tæthed af ørredyngel i perioden fra 2009-2019 er 7,2 pr. meter vandløb.

Removal of barrier in 2008 resulted in immediate increase in trout population downstream (Figure 1) and upstream (Figure 2)

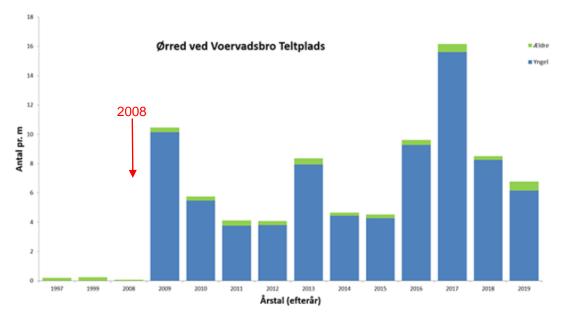
Figur 2: Tætheden af ørred på en 160 meter lang strækning ved Voervadsbro Teltplads opdelt i yngel og ældre.

Den gennemsnitlige tæthed af ørredyngel i perioden fra 2009-2019 er 7,2 pr. meter vandløb.
