# Real-time monitoring of a roadside nature-based solution: Hydraulic behavior, inlet performance and system limitations

This paper examines the potential of enhanced monitoring to improve understanding of hydraulic behavior in nature-based solutions using sensor technology. The study documents the design and construction of a comprehensive monitoring setup deployed to capture high-resolution hydrological and water-quality data from a roadside nature-based solution treating road runoff. A controlled stress test was conducted to simulate intense rainfall and assess system response, revealing design limitations

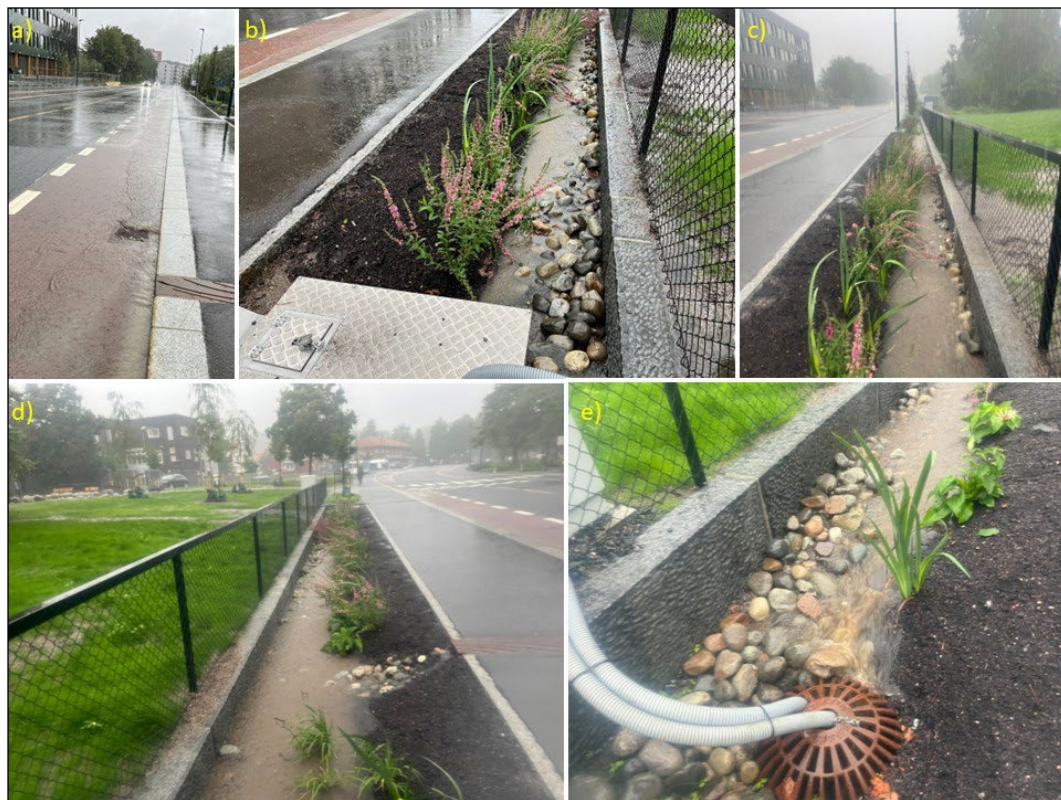
Figure 3. Observed hydraulic behavior of the roadside NbS facility during an intense rainfall event associated with Storm Hans (07 August 2023, afternoon). (a) Runoff from the road surface and bicycle lane entering the system; (b) Inlet zone showing ponding and additional inflow from the adjacent lawn; (c) Mid-section illustrating conveyance of runoff along the trench with continued lateral inflow; (d) Downstream section showing temporary storage and flow routing within the system; (e) Outlet structure where runoff is discharged to the downstream manhole.

During the 7 August 2023 Storm Hans event, the intense rainfall revealed the system's behavior, with inlet inflow and lawn-generated overland flow loading the entire facility, causing ponding along the trench and rapid discharge downstream, as illustrated in Figure 3.

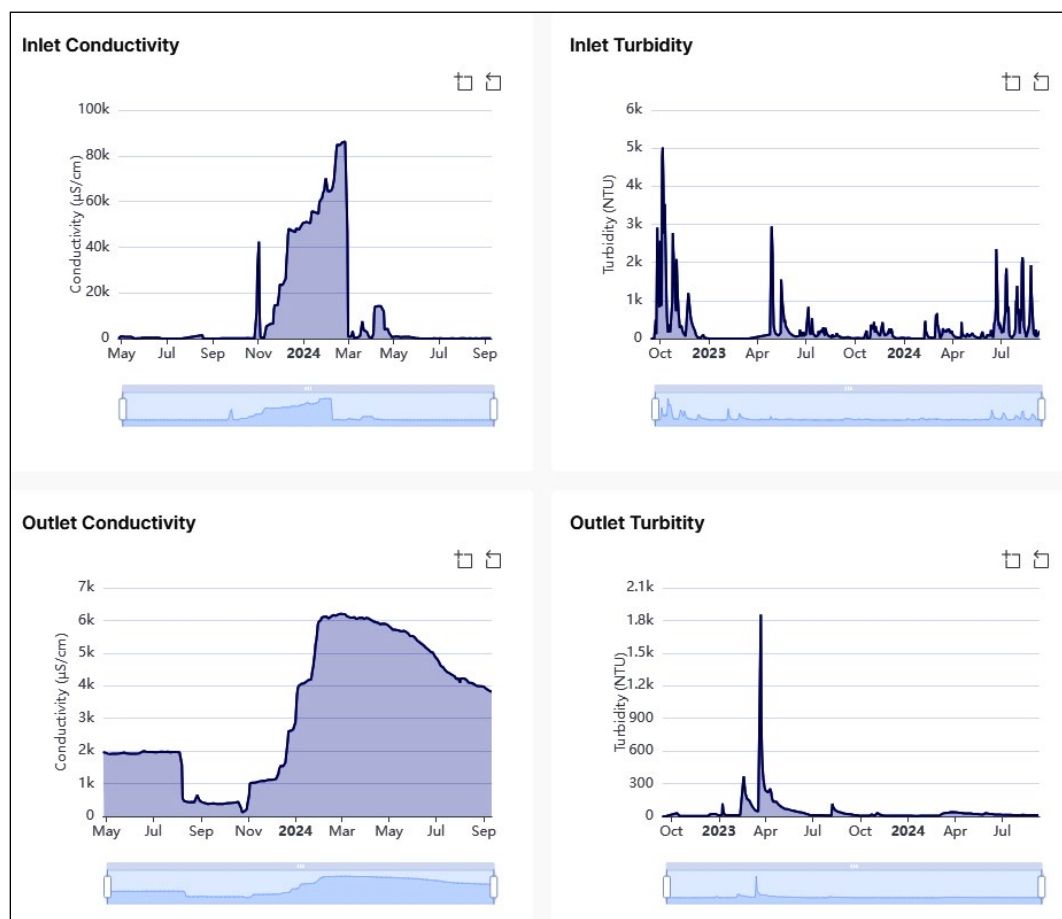
Figure 4. Example of long-term monitoring data from the Tåsenveien facility showing electrical conductivity ( $\mu\text{S}/\text{cm}$ ) and turbidity (NTU) at the inlet (N1) and outlet (N2). The time series illustrate strong event-driven variability at the inlet and attenuated but still variable responses at the outlet.

Figure 4 provides an example of the monitored time series. At the inlet (N1), turbidity and electrical conductivity showed strong event-driven fluctuations, with short-duration peaks indicating rapid mobilization of sediments and dissolved constituents during rainfall events. These patterns illustrate the variable nature of

Outlet measurements (N2) exhibited more attenuated responses, with lower peak magnitudes and more gradual temporal variation. The differences between inlet and outlet signals indicate that the system modifies incoming runoff through a combination of surface storage, mixing and subsurface flow processes, although the persistence of temporal variability at N2 suggests limited buffering capacity under dynamic loading conditions.

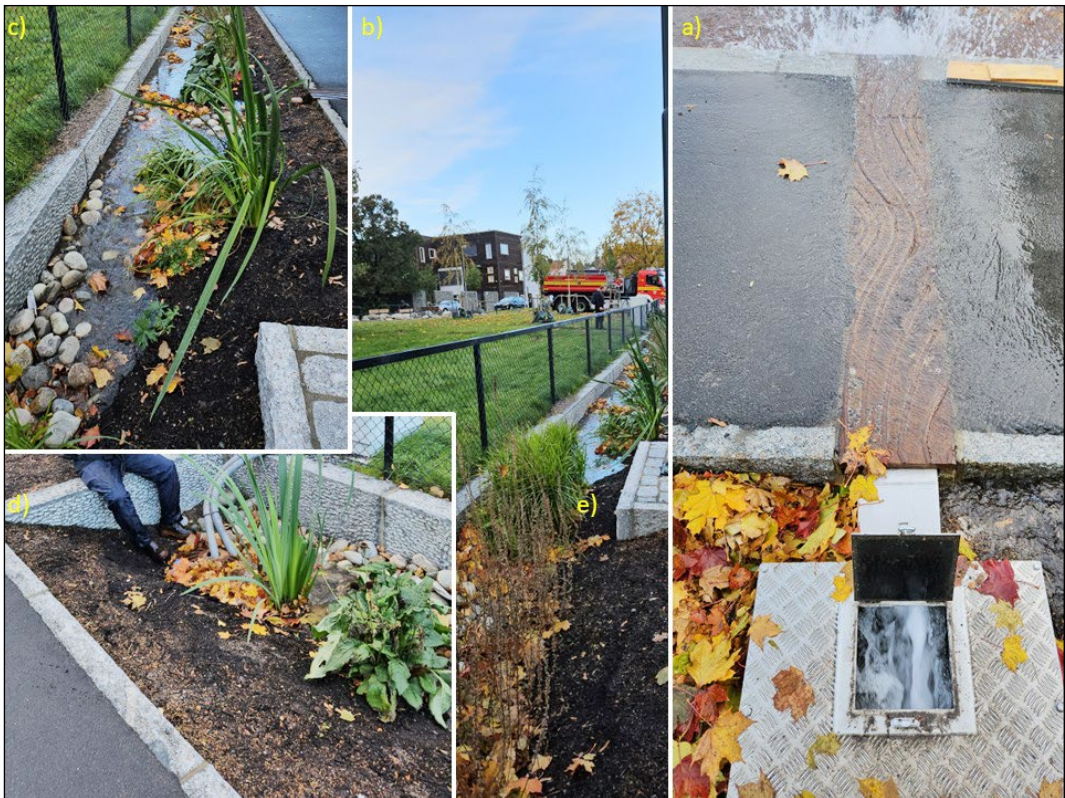
Figure 6. Photographic documentation of the 23 October 2023 stress test showing inflow at Inlet 1 (a), mid-section flow conveyance (b), approaching flow near the outlet (c) and discharge into the downstream manhole (d).

The observed flow pathways and system response during the test are illustrated in Figure 6.
